Project Ref: 22514

## STRUCTURAL REPORT

ON: CONSTANTINE CHURCH HALL  
FOR: CONSTANTINE PARISH COUNCIL  
DATE: JANUARY 2022  
PREPARED BY: M W PERRY B.Eng (Hons), MRICS, I.Eng,  
AMIStructE

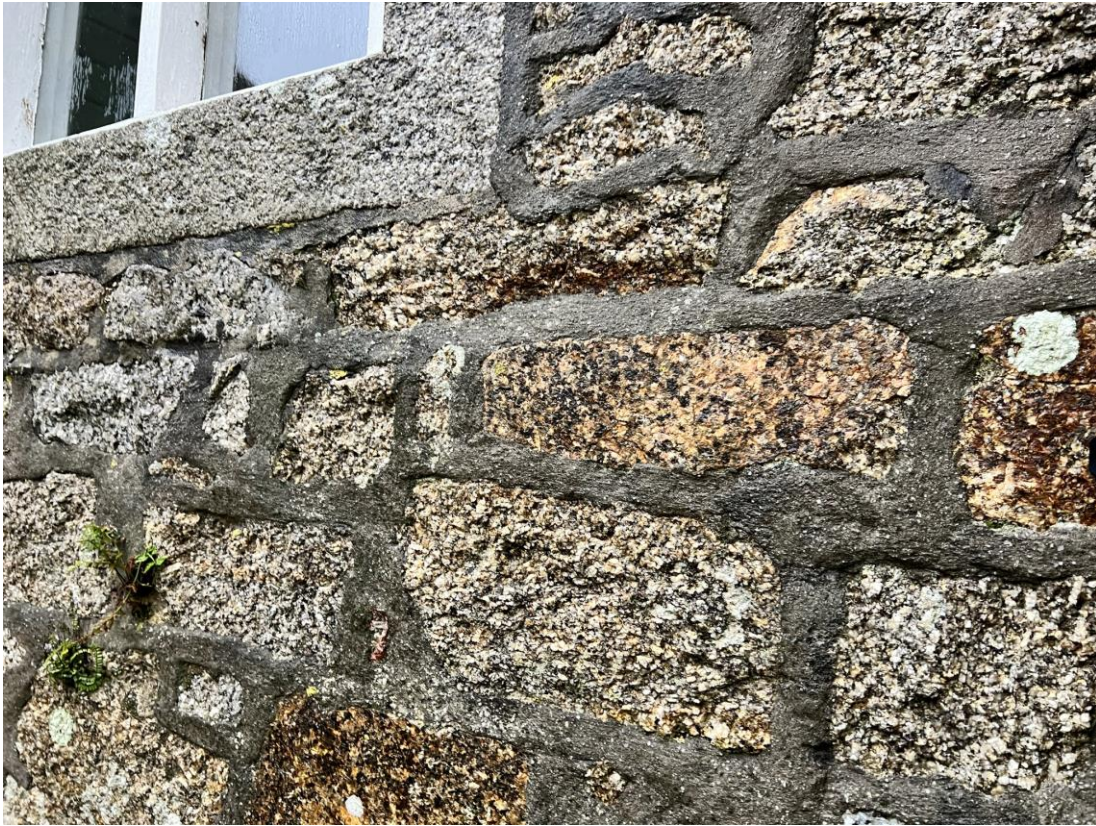
- 3.21 The external walls were pointed with what appeared to be a cement-based mortar and this appeared to have been patched up on multiple occasions over the building's past. The pattern of some of the more recent pointing would indicate some former cracking to the centre of the eastern elevation as well as to the western side of the north gable of the porch area. The pattern of the pointing would indicate some thrust type movement having occurred to the roof within this area.

- 4.2 Condensation was prolific throughout the building but it was unheated at the time of our inspection and understood to have been empty for some time. The internal faces of the external walls were finished with what appeared to be a cementitious plaster and cement had been used in many area of repointing outside. Solid natural stone walls should have breathable materials applied to them such as lime-based mortars and renders to allow moisture to escape. If moisture becomes trapped in walls it can damage the stonework and also increases damp levels inside the building. In this case the walls were predominantly granite, which is a very hard stone, and therefore there were no signs of damage having been caused as it may have been with a softer sedimentary stone.

Figure 1 – Cement pointing noted in multiple locations.

- 4.3 We would recommend that all cementitious materials are removed both internally and externally and a lime based mortar used to replace them. Insulated lime plaster could be considered internally in order to try and retain some heat within the building and to limit condensation.

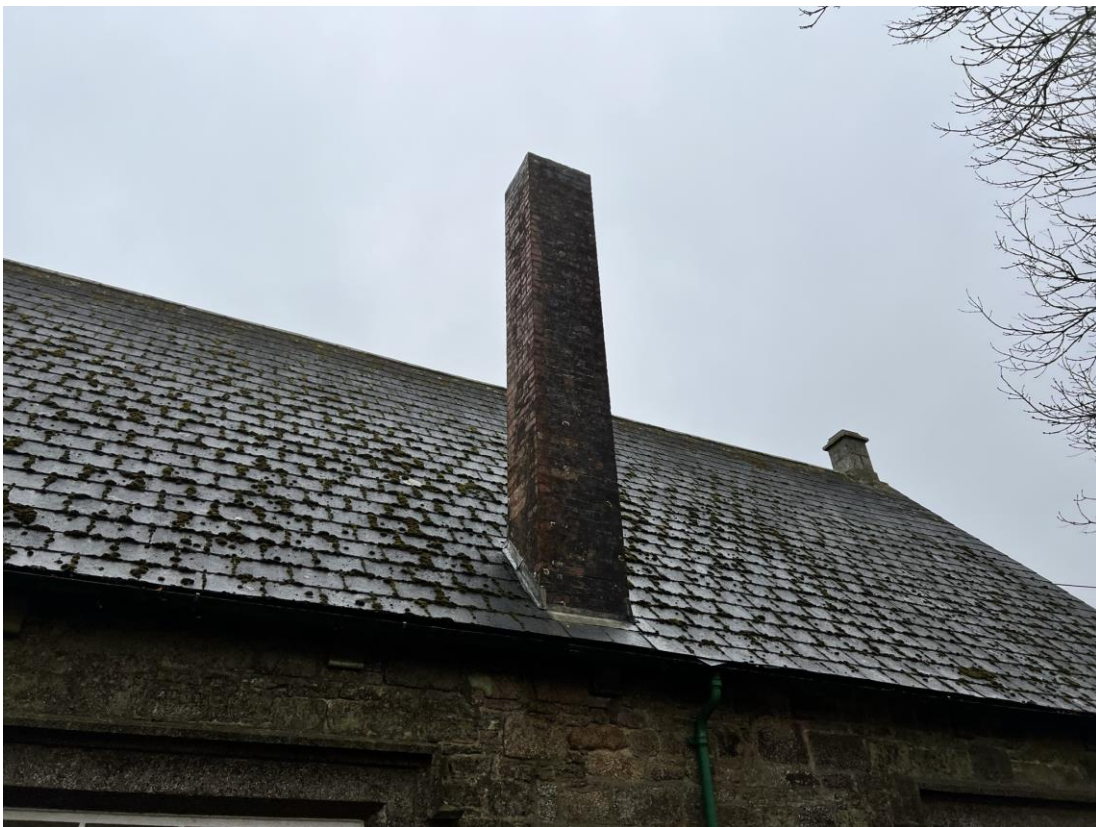
- 3.22 The northern elevation of the main hall had a chimney stack measuring approximately 600 x 600mm on plan extending up from the roof pitch by in excess of 4m. The stack was too high to check with a spirit level however appeared to be generally vertical with no signs of a significant lean when sighted through from ground level. The stonework to the top of the northern wall below the chimney stack had several eroded joints present and some evidence of patch repairs having been undertaken to the pointing.

- 4.4 A detailed inspection of the roof was not possible; however, the roof lines were relatively straight and level and there were no signs of significant recent movement from inside. The roof finishes were also in reasonable condition and didn't appear to be in need of immediate replacement, however, maintenance and partial replacement of the rainwater goods, barge boards etc will need to be considered. A closer inspection of the roof finishes are recommended and the building is likely to require re-roofing in the next 5 years or so.

Figure 2 – Roof coming to end of natural life. Very high chimney to north side of building.

- 4.5 Consideration should be given to removing the tall brick chimney to the north side of the main hall. It did not appear to have moved significantly but it was noted as being very slender and damp issues were present below.

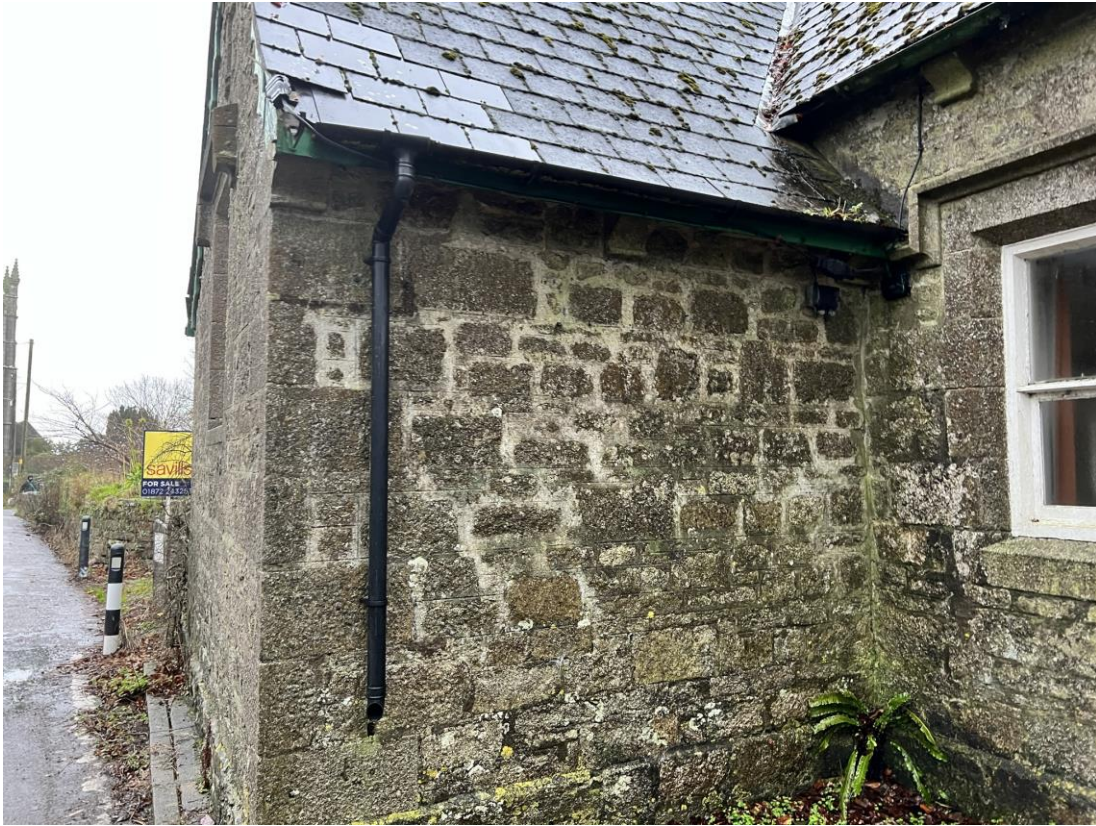
- 4.6 The external walls were not suffering from any significant cracking at the time of our inspection, although, there was evidence of some scarring from crack repairs in the past. This was generally around the porch area where some historic roof spread appeared to have occurred. This type of movement happens when truss members are inadequately sized to resist the loads applied to them and this causes some lateral movement to occur around eaves level. Poor fixing down of the trusses can also contribute to the issues.

- 4.7 The scarring from repaired cracks had not reopened at the time of our inspection, and they did not appear to be recent repairs. The movement is likely to be historic, however, some thought should be given to roof strengthening and repair when the finishes are next replaced.

Figure 3 – Evidence of historic repairs and possible movement to porch area.

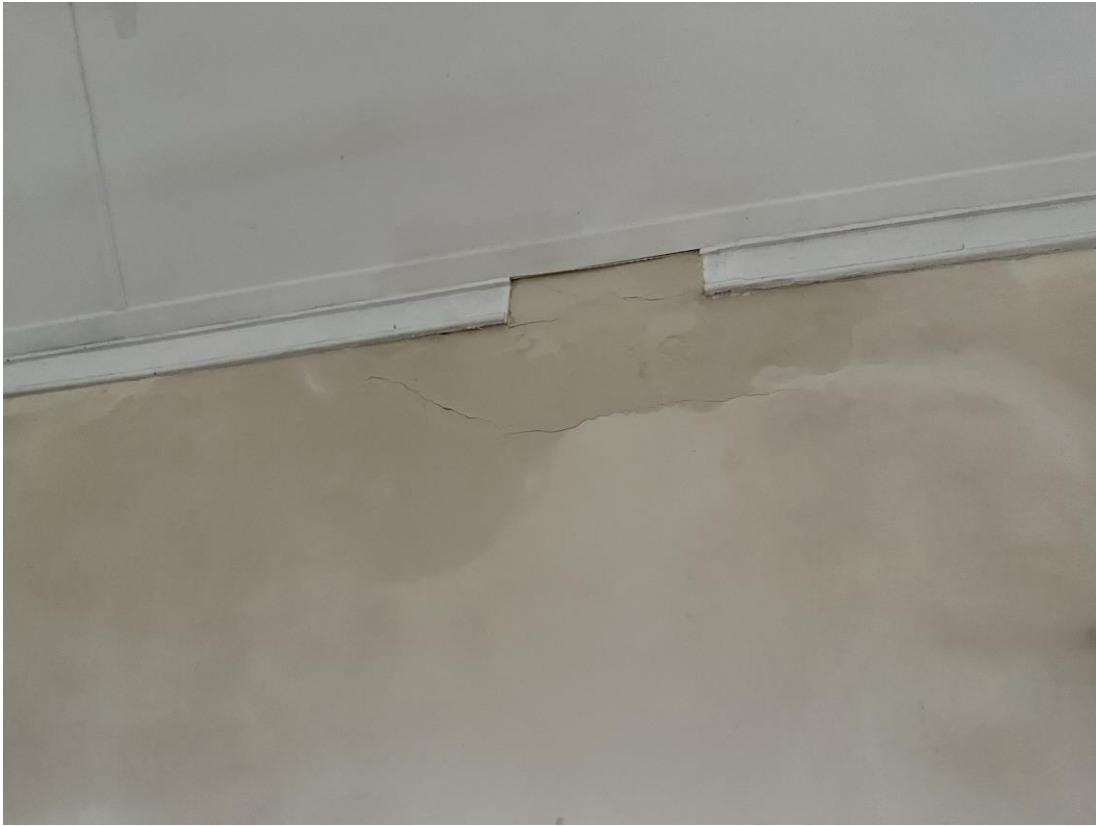
- 3.6 The staining to the northern elevation was significant and horizontal cracking of 1-2mm wide was noted to the top of the wall in this area. The wall below the chimney stack was checked with a spirit level and the top section was found to lean outwards by approximately 5mm per 600mm length and although the cracking was relatively minor the outward lean could be due to wind pressures onto the chimney stack.

*Figure 5 - Damp issues and cracking around base of north chimney.*

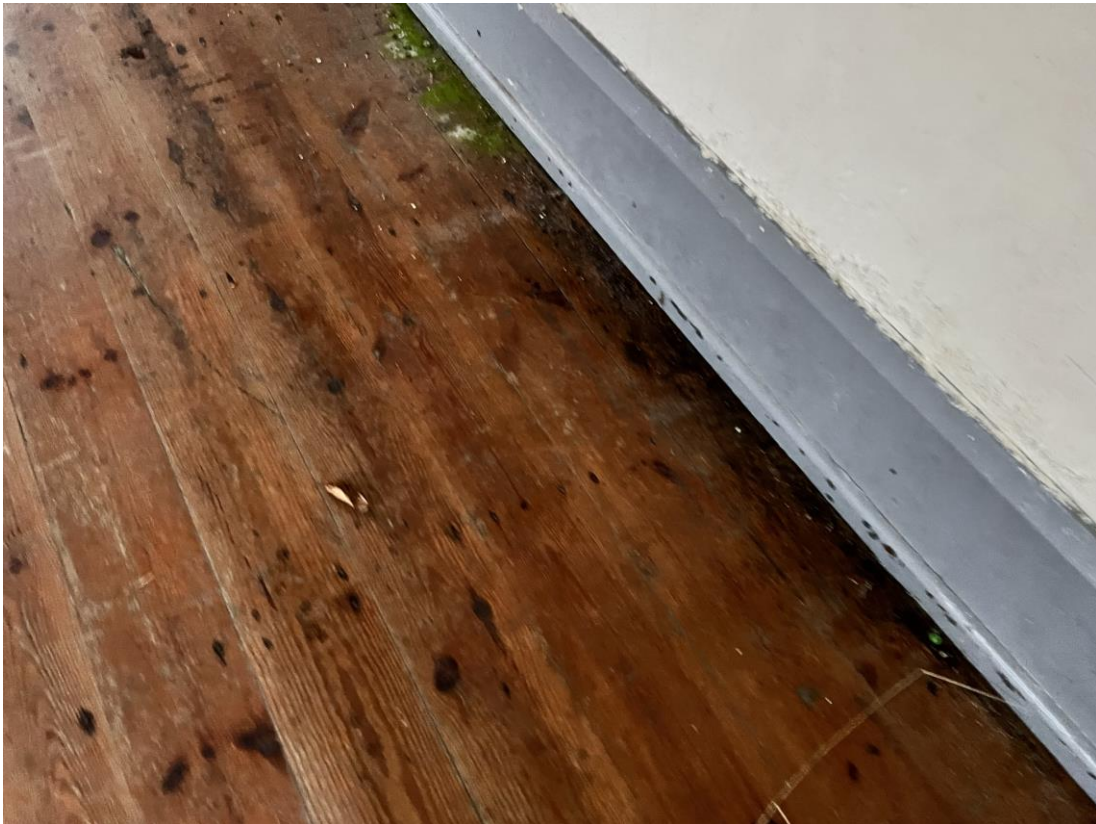
- 3.10 The edges of the timber boards were darkened in some areas, particularly around the southwest corner and the centre of the southern elevation and it is likely that water damage has occurred to the timber bearers in these areas that will require remedial work to be undertaken. 4 no. vents were noted around the north elevation at floor level with a further four to the south. The vents were randomly spaced, and none were observed to the eastern end of the north side of the building.

- 4.1 Damp issues were present in multiple locations and will need to be investigated further with remedial action taken. Due to the presence of timber floor and roof structures some damage may have been caused where water ingress has been ongoing for some time, particularly around the centre of the south wall of the main hall and the west end of the kitchen.

*Figure 6 - Rot to floor around centre of south side of main hall.*

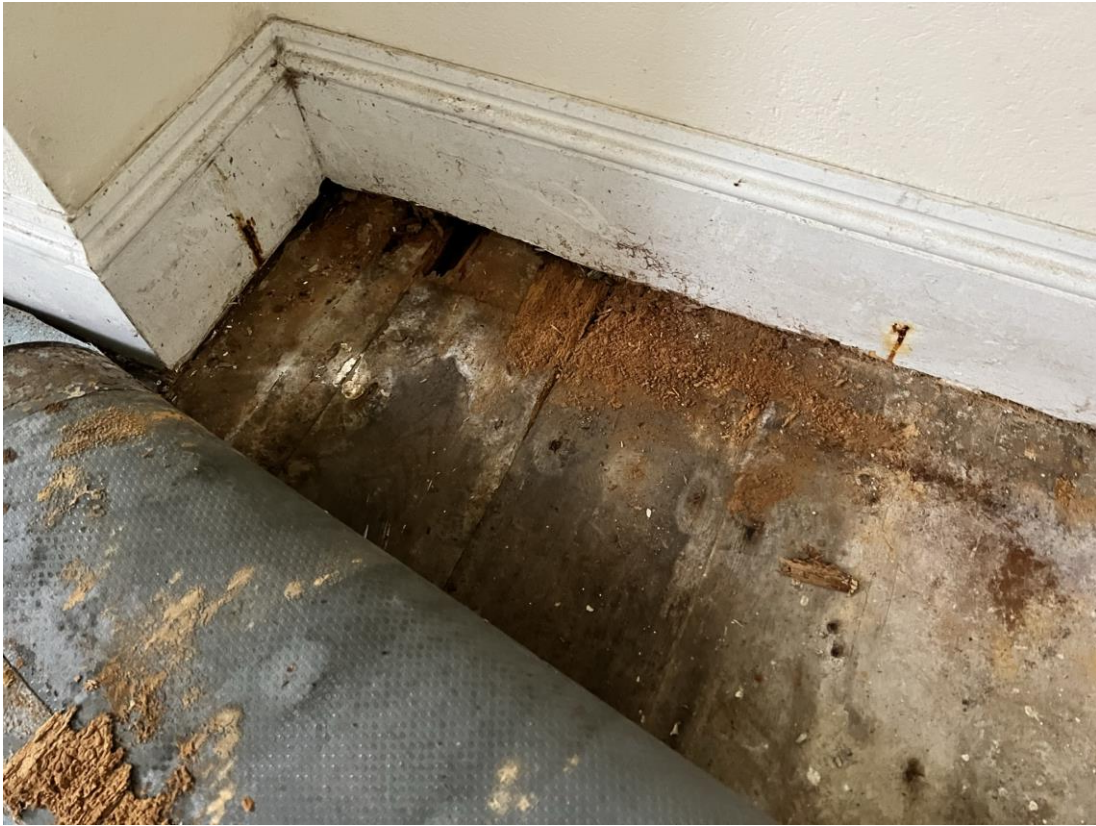
*Figure 7 - Rotten floor boards to west end of kitchen.*

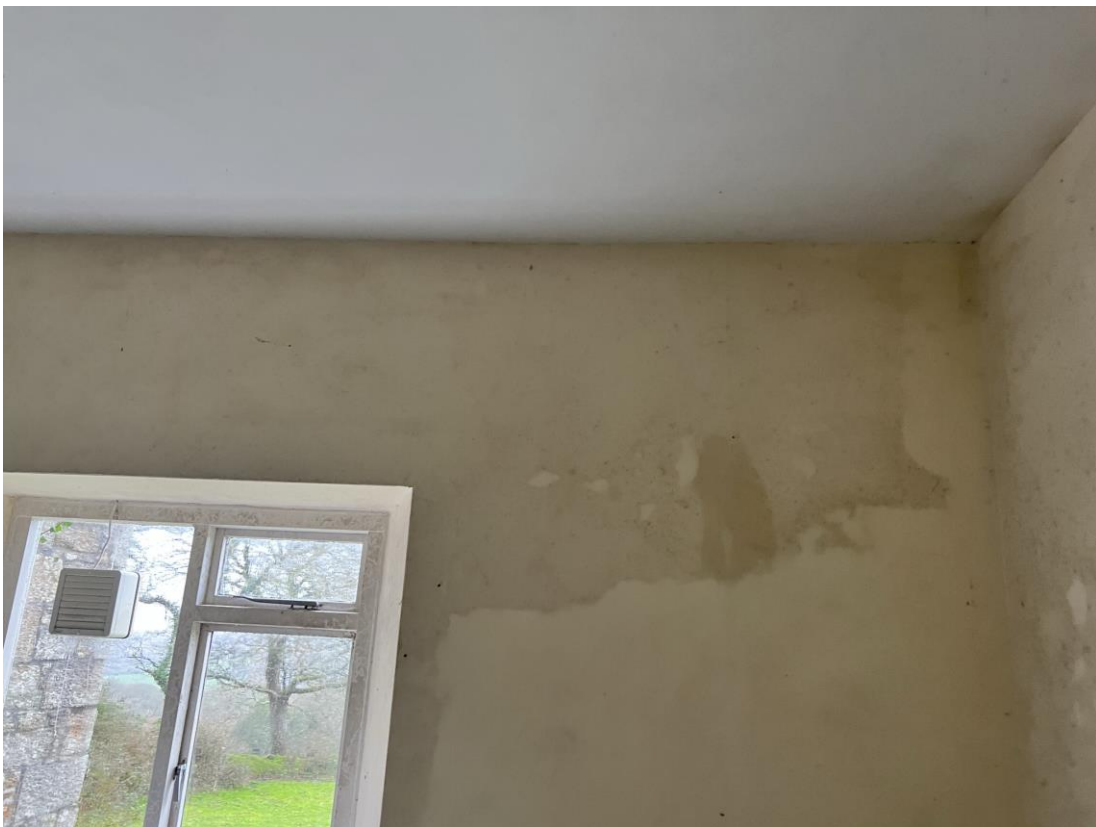
- 3.17 Damp staining was noted around the chimney stack to the western elevation, particularly at ceiling level, and damp staining was noted around the top half of the southern external wall.

*Figure 8 - Significant damp staining to tops of kitchen walls.*
